Destruction of glass surfaces: Inevitable or preventable?

Serge Perkoff & Stephen Byers, Ritec International Limited

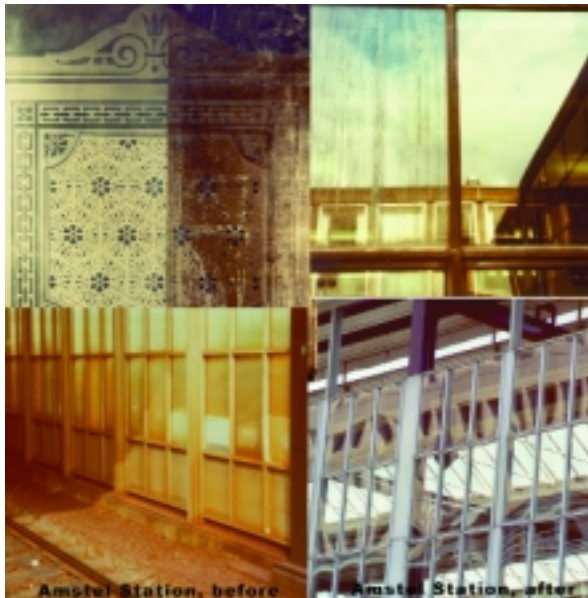
Above: Pictures 1-4

Many glazed areas have benefited from the process, bringing glass to an 'as new' condition. Its intended performance of visibility, clarity and cleanliness restored, as illustrated by photographs 1 to 4.

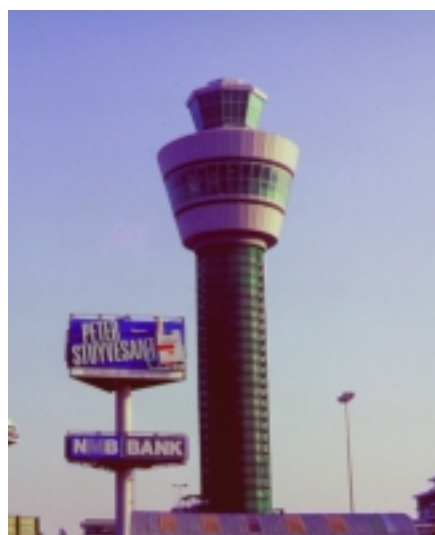
(left) Visual Control Tower at Schiphol Airport, Amsterdam

In 1991, ClearShield Glass panels were installed in the control tower of the Schipol Airport in Amsterdam. The high specification and expensive panels, produced by St Gobain were treated in the factory prior to installation.

When the initial treatment was carried out by Ritec Benelux, the service interval was expected to be five years. The durability of the protection varies depending upon the exposure of the glass. Since installation, the panels have been cleaned approximately once a month.

Ten years on, the airport authorities requested that the panels be inspected to assess the current performance of the glass and if necessary carry a new application to prevent the loss of benefits provided by ClearShield which may have been affected due to years of abrasion on the glass surface. Following tests it was determined that a re-application of the system was unnecessary. The results showed that 10 years on, the system was still performing to its original expectations, and re-application was not yet necessary. Many other airports in the world today benefit from a similar protection.

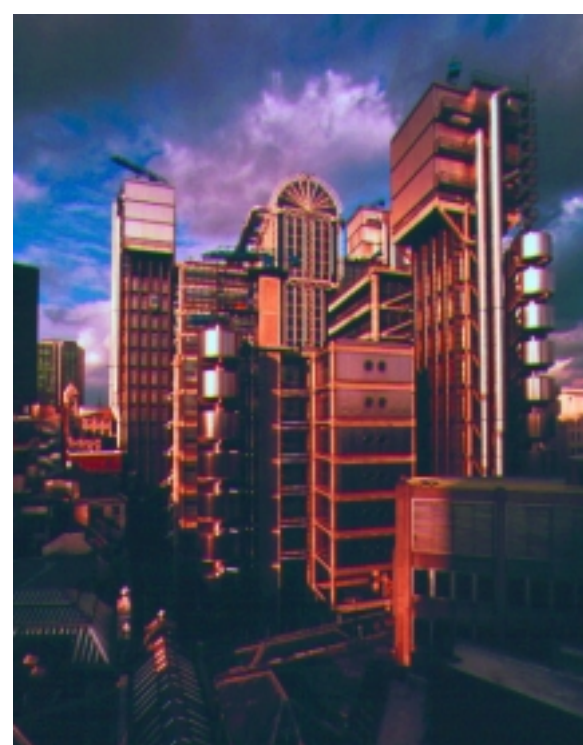
(below) Lloyds of London Building

During routine inspections in the early 1990's, the owners of the Lloyds Building found that the paint on the frame around the atrium was shedding and plating onto the glass, and was beginning to adhere to the surface. This was making the cleaning extremely difficult. The glass was successfully converted into ClearShield Glass. Today, the paint still flakes, but thanks to the "non-stick" surface it is still easily wiped off, there has been no long term staining and conventional cleaning methods are still sufficient to maintain the glass.

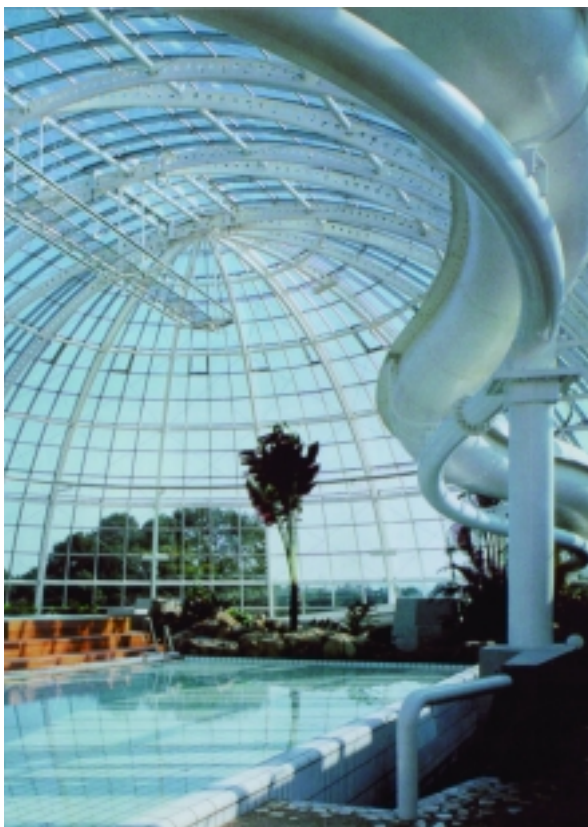
Factory conversion to ClearShield glass before installation, Tsuyama City.
